ROAD MARKINGS AND WINTER SERVICE

THE CHALLENGE OF KEEPING THE LINES INTACT

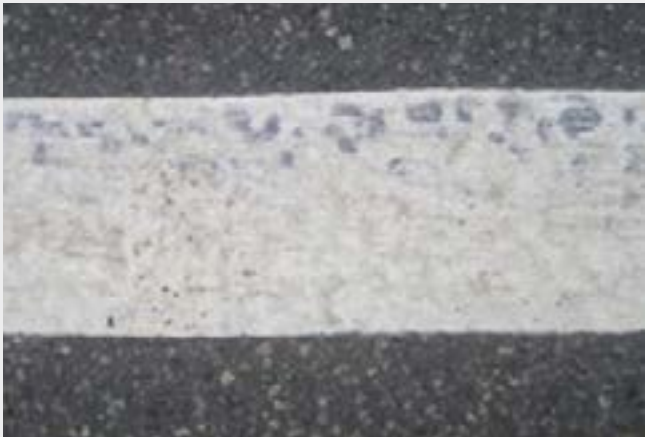
An example of a damaged continuous line

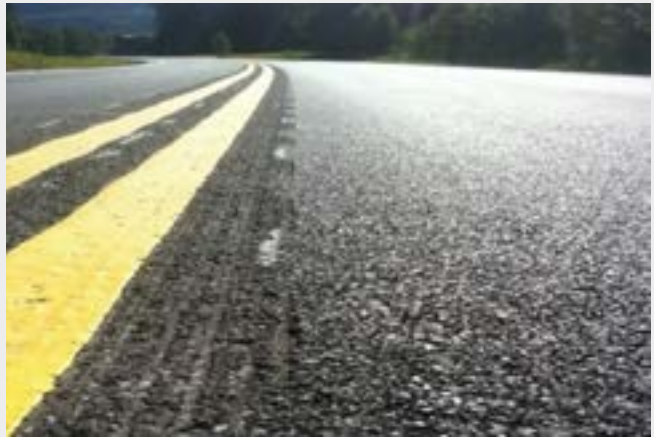
An example of a continuous line in a flat milled track

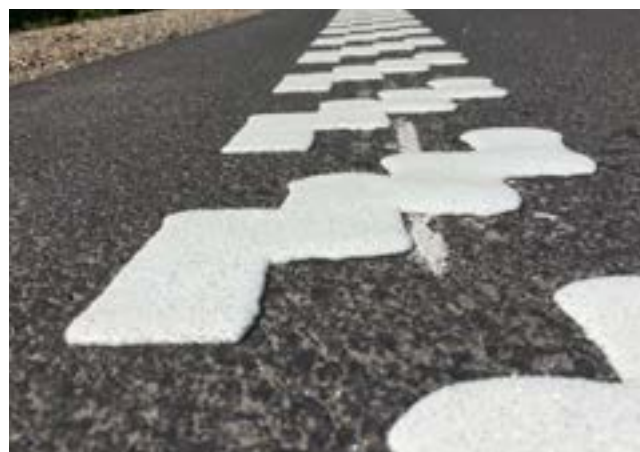
An example of a stair flex line type

As a third option, you can choose a type of marking such as the Stair-flex line or the Edge-flex line (comb line), where the blade from the snow plow will slide on the line and not "grip" the edge of the markings so easily.

This solution works best when the snow plow blades in rubber are used because snow plow blades in a harder material have a higher risk of damaging the whole line.

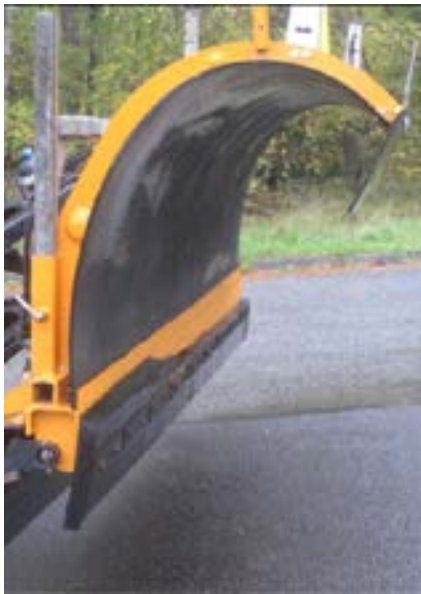
A - Rubber blade

For this testing, three different plows were used: **A** - Rubber blade; **B** - Steel/ceramic blade; **C** - Hard metal blade.

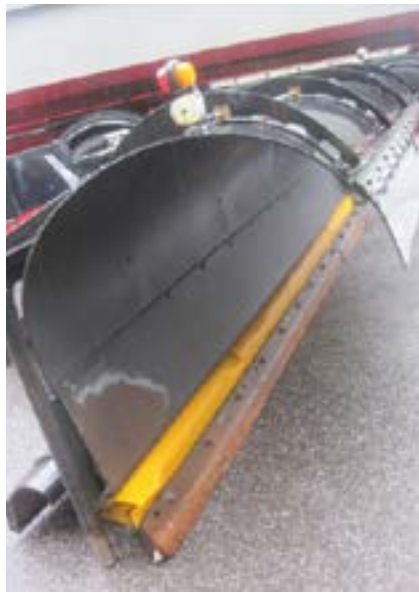
B - Steel/ceramic blade

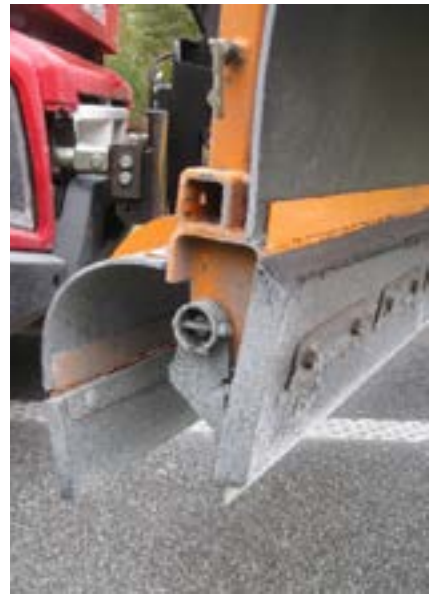
C - Hard metal blade

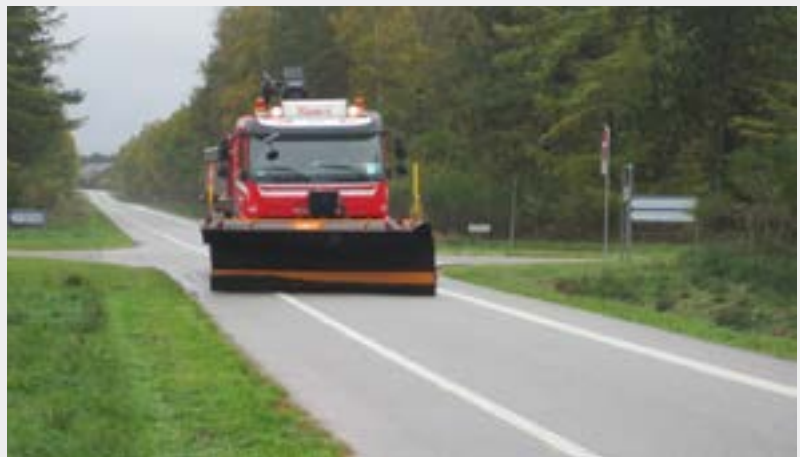
A snow plow machine conducting the test

It was agreed to carry out 10 runs with each of the three plows in the order A, B and C, corresponding to an increasing degree of wear on the road markings, and with a speed of 50 km/h. In addition, it was agreed that RL values are measured initially and repeated after use of each of the three plows.

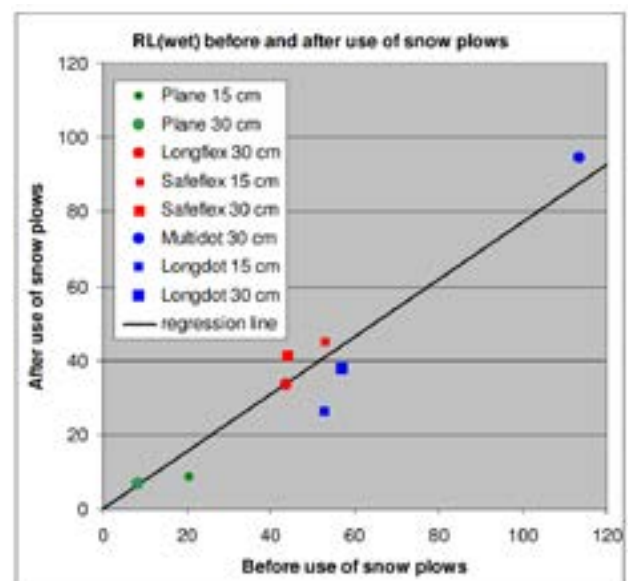
Comparison of RL(wet) before and after use of snow plows.

The RL values of the road markings were measured before as well as after the test, and showed a decrease corresponding to an average of 23 %.

As an example, you can see the longflex line on the table on the right. Before the use of snow plows, the RL (wet) was around 45 mcd/m²/lux, after the snow plows it became 35 mcd/m²/lux - making a total of 23 % decrease of RL (wet).

This decrease can be attributed to the overall effect of the plows, of which plow C can probably be attributed most of the decrease.
